Title		Pages:
ENVIRONMENTAL QUALIFICATION TEST REPORT OF RAYCHEM N-MCK NUCLEAR MOTOR CONNECTION KITS		36
WYLE REPORT NO. 58442-3		Enclosures:
Report Number:	Date:	
EDR-5034	May 1, 1981	
Tested by:	Signature:	Date:
Wyle Laboratories	(see report)	July 28, 1980
Prepared by:	Signature:	Date:
C. F. Albertalli	<i>C. F. Albertalli</i>	May 1, 1981
Approved by:	Signature:	Date:
R. J. Scott for Product Management	<i>R. J. Scott</i>	1 May 81
Approved by:	Signature:	Date:
G. J. Clarke for Technical Operations	<i>G. J. Clarke</i>	May 1 81
Raychem Corporation Energy Division

REPORT NO. 58442-3
OUR JOB NO. 58442
CONTRACT ---
YOUR P. O. NO. A01183

ENVIRONMENTAL QUALIFICATION TEST REPORT
OF
RAYCHEM N-MCK NUCLEAR MOTOR CONNECTION KITS
FOR
RAYCHEM CORPORATION
MENLO PARK, CALIFORNIA

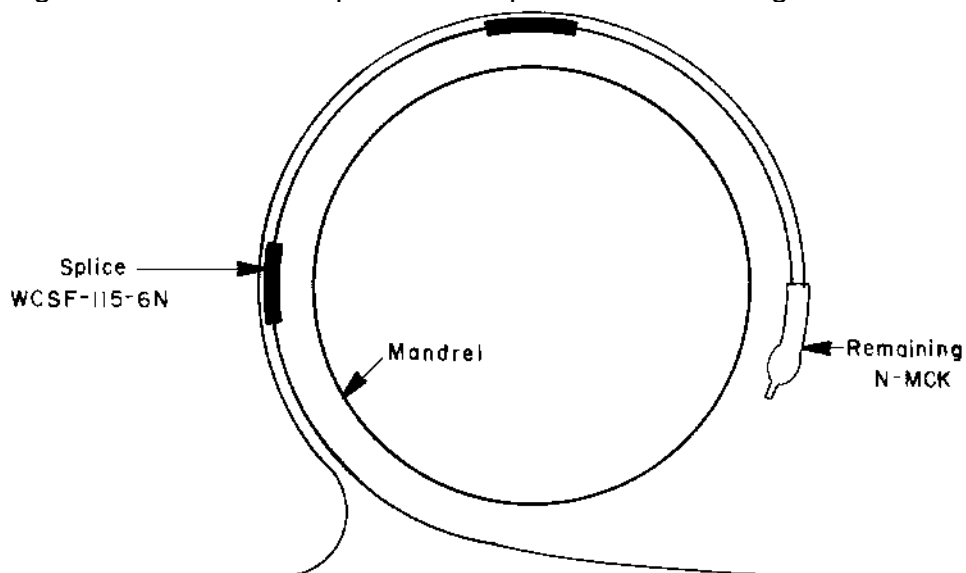
FIGURE 2. Modified Specimen Loop

After the thermal aging, it was observed that the factory sealed end had disbanded on one of the two N-MCKs on specimens 3-1 and 3-3. The two affected N-MCKs were removed, and the specimen loop spliced together to continue the test. The splice in the specimen loop where the N-MCK was removed was insulated with WCSF-N heat shrinkable tubing. Therefore, only one N-MCK motor connection was left on specimen loops 3-1 and 3-3 for the remainder of the test program. The modified specimen loops are shown in Figure 2.

A discussion of the cause of the disbondment of the N-MCKs is included in Appendix C (provided by Raychem).

Corrective actions to incorporate quality control improvements have been implemented. The manufacturing specification has been rewritten for N-MCK bonded caps incorporating beneficial changes in the process that were discovered during the investigation to further improve bond strength and reliability. All testing subsequent to implementing the modified manufacturing procedures has confirmed consistently good bonds with no evidence of debonding, including tests to duplicate the accelerated aging conditions under which the initial samples debonded.

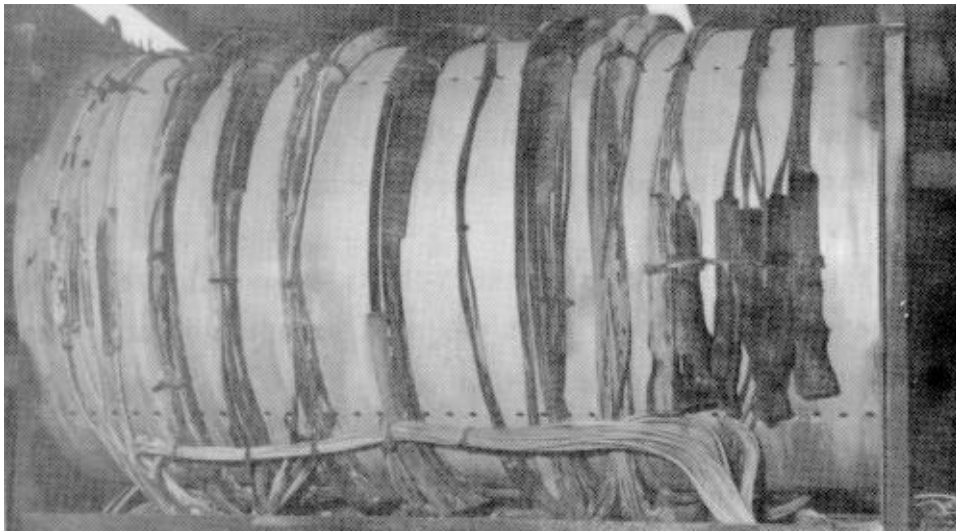
FIGURE 9. Mandrel After Removal from Vessel

The extension wires were cut inside the vessel so that the mandrel could be removed. This also allowed the penetrations to be inspected. It was found that some of the wires in the penetration had a low insulation resistance and would not pass the 3.6kV a-c voltage withstand test. The specimens associated with the penetration wires having a low insulation resistance were retested. The retest of specimen 3-3 showed high values of insulation resistance, and the specimen passed the voltage withstand test. The low value previously measured on this specimen can therefore be attributed to the penetration and not the specimen.

Specimen loops 3-1, 3-2, and 3-4 had cracks in the wire insulation near the N-MCK samples. These loops were removed from the mandrel and tested with the N-MCK's immersed in water. The cracked wire insulation was kept above the water for these tests. All the N-MCK's yielded a high insulation resistance value and passed the voltage withstand test thereby demonstrating that the previously low insulation resistance values were caused by insulation failure elsewhere in the test loops.

Visual examination of the N-MCK's showed surface degradation and some crazing. This was most apparent in specimens 3-5 and 3-6.
