Title		Pages:
ENVIRONMENTAL QUALIFICATION TEST REPORT OF RAYCHEM N-MCK NUCLEAR MOTOR CONNECTION KITS		36
WYLE REPORT NO. 58442-3		Enclosures:
Report Number:	Date:	
EDR-5034	May 1, 1981	
Tested by:	Signature:	Date:
Wyle Laboratories	(see report)	July 28, 1980
Prepared by:	Signature:	Date:
C. F. Albertalli	<i>C. F. Albertalli</i>	May 1, 1981
Approved by:	Signature:	Date:
R. J. Scott for Product Management	<i>R. J. Scott</i>	1 May 81
Approved by:	Signature:	Date:
G. J. Clarke for Technical Operations	<i>G. J. Clarke</i>	May 1 81
Raychem Corporation Energy Division

REPORT NO. 58442-3
OUR JOB NO. 58442
CONTRACT ---
YOUR P. O. NO. A01183

ENVIRONMENTAL QUALIFICATION TEST REPORT
OF
RAYCHEM N-MCK NUCLEAR MOTOR CONNECTION KITS
FOR
RAYCHEM CORPORATION
MENLO PARK, CALIFORNIA

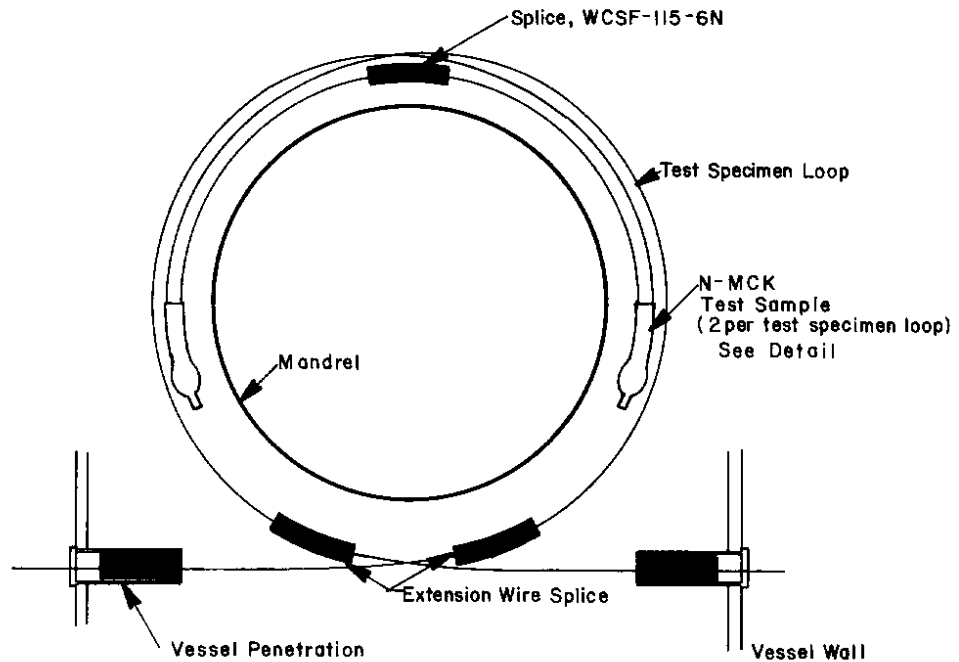
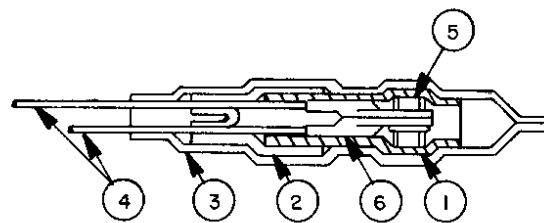
FIGURE I. SAMPLE CONSTRUCTION

- 1 - WCSF - 300 - 3U.
- 2 - 302A812-52/144 (S-III9 Adhesive).
- 3 - MCKF-500 /144 (S-III9 Adhesive)
- 4 - 1/C-12 AWG XLPE Insulation, Rockbestos Firewall III (.030 inch insulation thickness) .
- 5 - 3/8" DIA x 3/4" Long Bolt .
- 6 - Ring tongue Terminals.

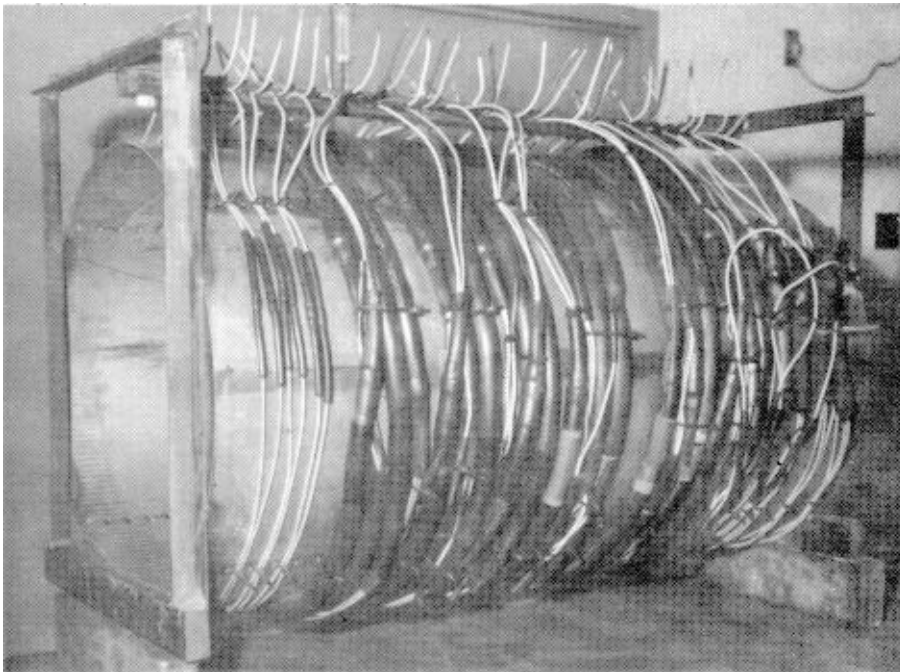
FIGURE 3. Mandrel and Samples (Specimens 3-1 through 3-6 are located at the extreme right of the mandrel.)

After the thermal aging, it was observed that the factory sealed end had disbanded on one of the two N-MCKs on specimens 3-1 and 3-3. The two affected N-MCKs were removed, and the specimen loop spliced together to continue the test. The splice in the specimen loop where the N-MCK was removed was insulated with WCSF-N heat shrinkable tubing. Therefore, only one N-MCK motor connection was left on specimen loops 3-1 and 3-3 for the remainder of the test program. The modified specimen loops are shown in Figure 2.

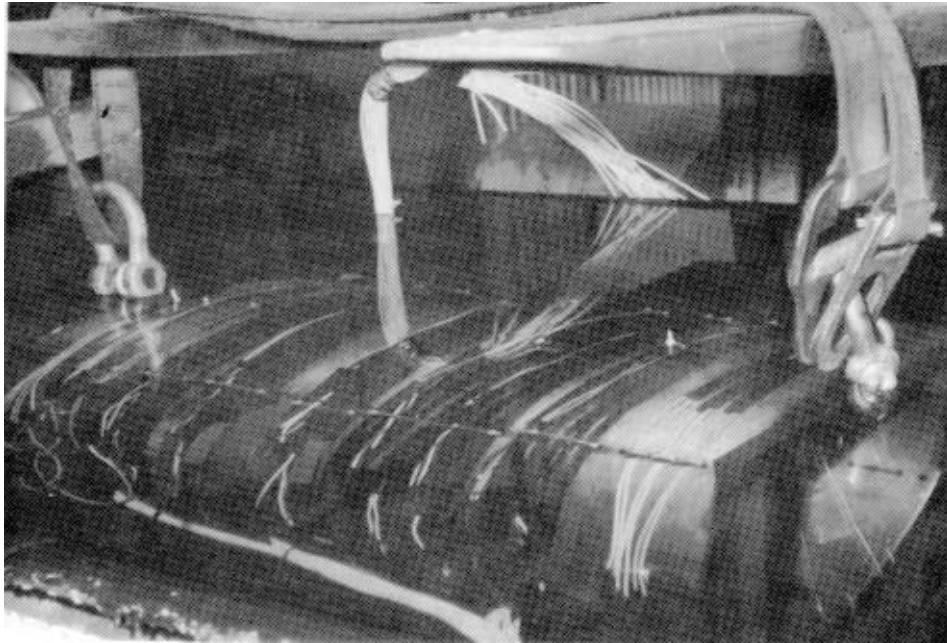
FIGURE 4. Mandrel and Samples Immersed in Water

The mandrel with the specimens in place was immersed in water, and the insulation resistance measurements made. This was accomplished by splicing long extension leads to each end of the test loops. The splices between the specimens and the extension leads were covered with WCSF-N heat shrinkable tubing. The mandrel immersed in water is shown in Figure 4.

All specimens again passed the five minute, 3.6kV a-c voltage withstand test. The insulation resistance values are given in Table 1 on page 14.

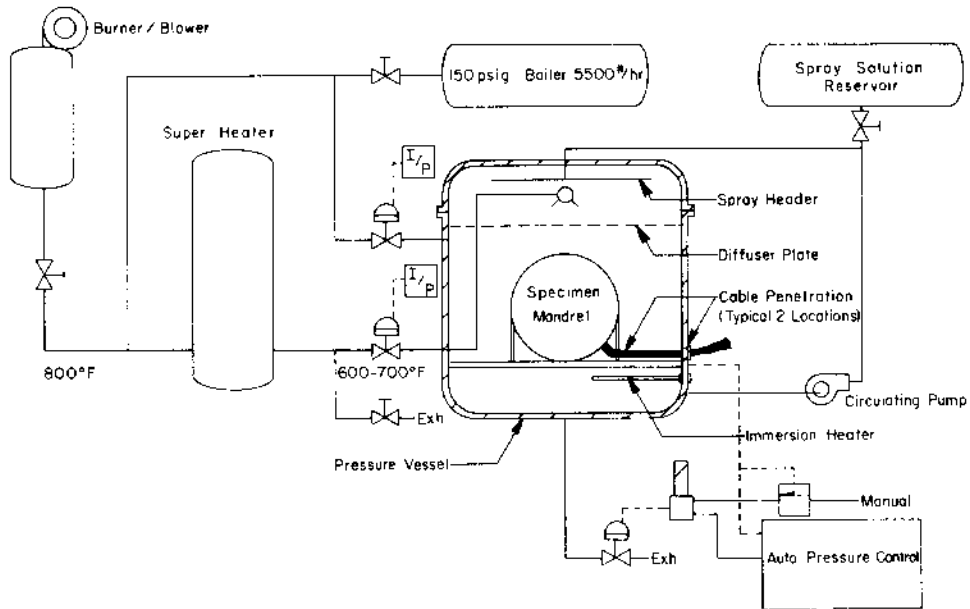
FIGURE 6. LOCA/MSLB Pressure Vessel and Auxiliary Equipment

The extension wires were cut inside the vessel so that the mandrel could be removed. This also allowed the penetrations to be inspected. It was found that some of the wires in the penetration had a low insulation resistance and would not pass the 3.6kV a-c voltage withstand test. The specimens associated with the penetration wires having a low insulation resistance were retested. The retest of specimen 3-3 showed high values of insulation resistance, and the specimen passed the voltage withstand test. The low value previously measured on this specimen can therefore be attributed to the penetration and not the specimen.
